Manhole Inspection Summary

Manhole # S31II_022MH

Insp Date: **4/6/07 2:17 PM**

Location Address: **121 MCMECHEN ST** Cross Street: **MOUNT ROYAL AVE**

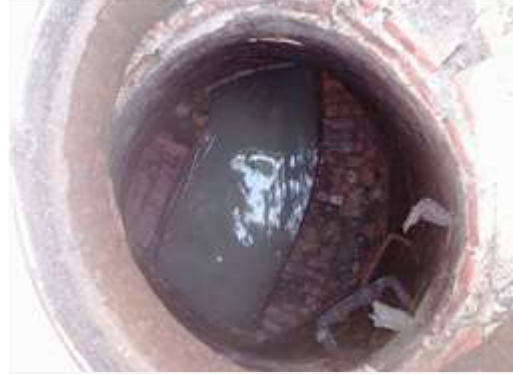
Top View

Corroded and missing steps. Evidence of surcharge - Bench debris.

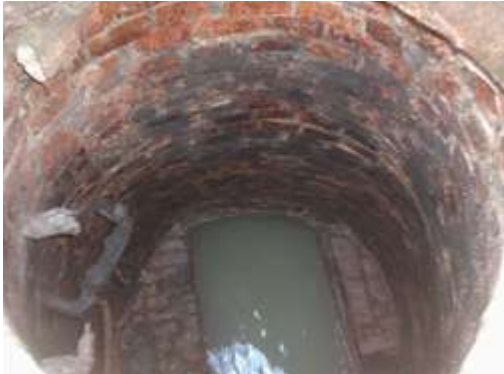
Defect

Frame leaks. Adjustment, Corbel and Barrel infiltration - other side.

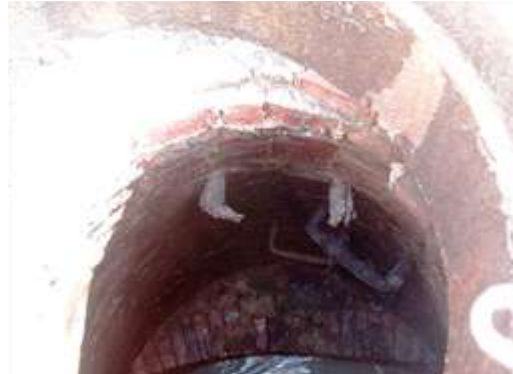
Defect

Frame leaks. Adjustment deterioration and infiltration. Corbel and Barrel infiltration.

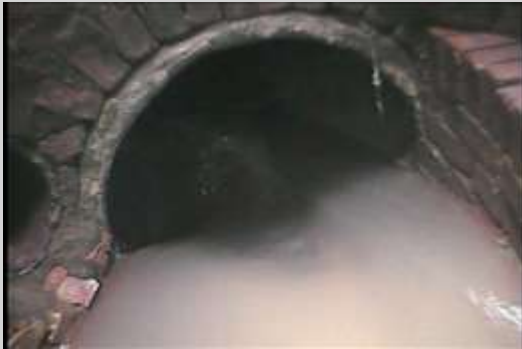
22 in. Circular Gravity Sewer Pipe Out @ 12 O'Clock

Infiltration: **Evidence** Pipe Seal Cond: **Unknown**

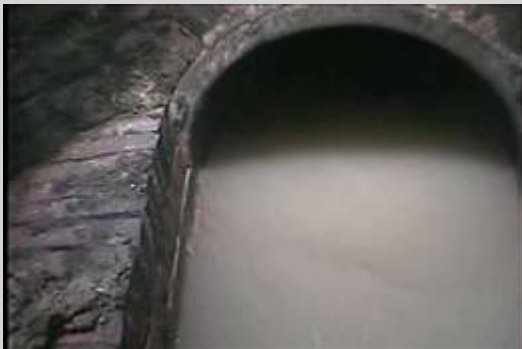
24 in. Circular Gravity Sewer Pipe In @ 8 O'Clock

Infiltration: **Evidence** Pipe Seal Cond: **Unknown**

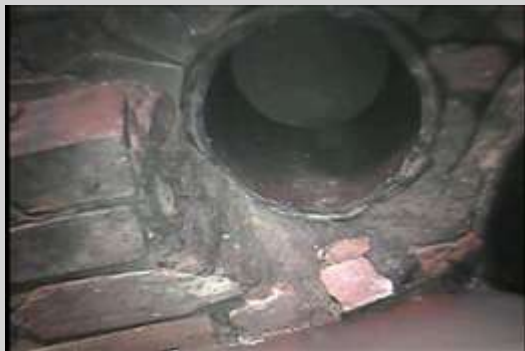
8 in. Circular Gravity Sewer
Pipe In @ 11 O'Clock

Infiltration: **Evidence** Pipe Seal Cond: **Cracked**

Connects To: **Stub connection / abandoned**
